# Buyers Guide to: Volkswagen Type 2 Split Screen

## The Show Car

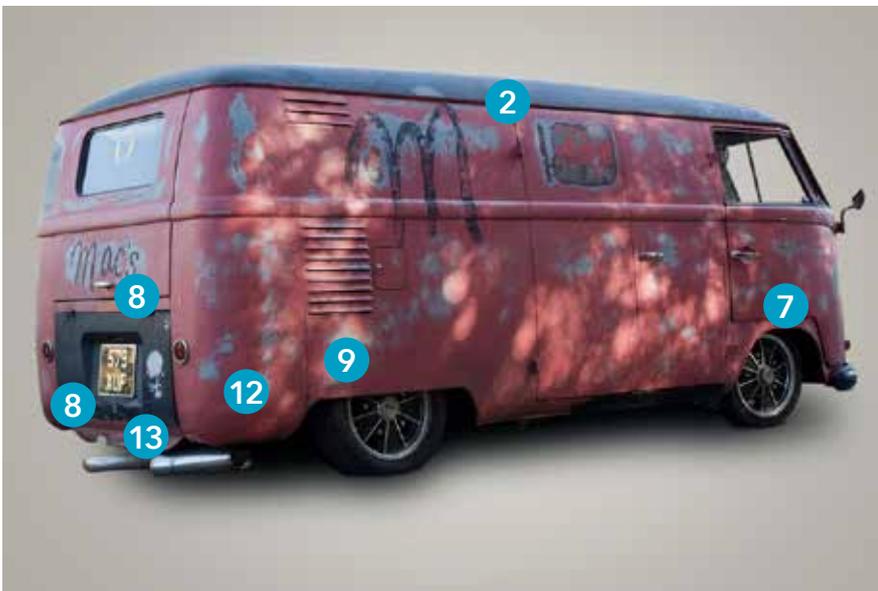
## Corrosion Hotspots

1. Lower front panel and inner front valance
2. Roof gutters
3. Front screen surround
4. Front roof panel around the airbox
5. Chassis legs front to rear, including outriggers and jacking points
6. Floorpan
7. Door bottoms
8. Bottom of the tailgate/engine lid
9. Inner and outer wheel arches
10. Inner and outer sills
11. Around the side windows
12. Rear corner of the engine bay, including the battery tray
13. Rear inner and outer lower valance
